Failure analysis.

By studying wheel bearings that have failed prematurely, SKF engineers have learned a great deal about the causes of bearing failure and how to prevent it. The photographs on the following pages can help you and your mechanics learn from the mistakes of others—and avoid making them yourself.

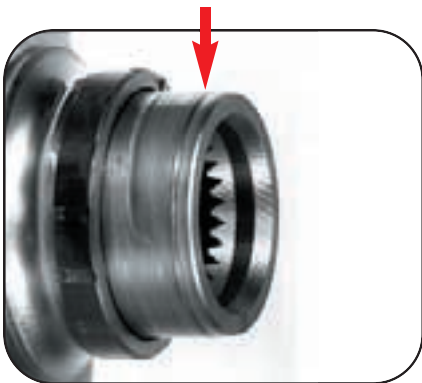
Damage during mounting bearing shaft misalignment.

If, during mounting operation, a misalignment of the inner rings in respect to the shaft occurs, plastic deformations can take place, both on the bearings and on the surrounding components. These deformations could affect the running conditions, generating noise and flaking at a later stage.

The photo above shows the plastic deformations on the shaft caused by a misaligned mounting of the bearing.

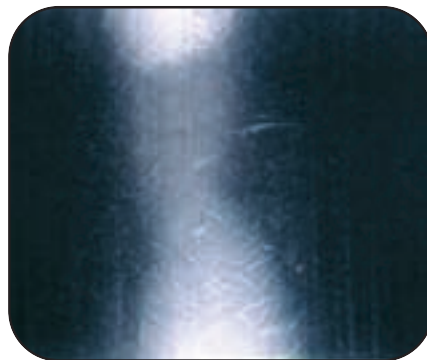
Magnification of a raceway showing imprints due to damaged balls.

NOTE: The bearing should not be used again after having been mounted in a misaligned way (or on a damaged shaft). In fact, the rolling elements could have also been damaged, and the over-rolling on the raceway could cause imprints.

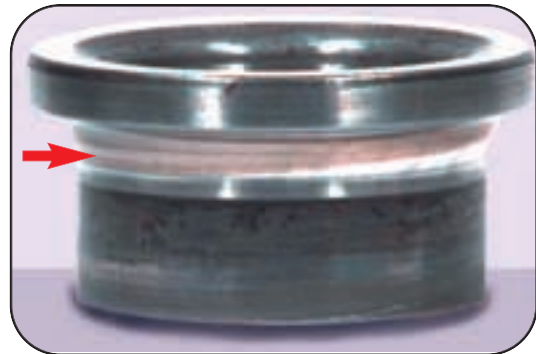
An excessive clamp load forces the rolling elements to work in non-ideal conditions, with an excessive preload. In this running condition the temperature could increase, leading to a loss of the lubricant properties of the grease and deteriorating the surfaces of the raceways. Flaking could occur at a later stage.

Large and colored path pattern, towards the shoulder diameter

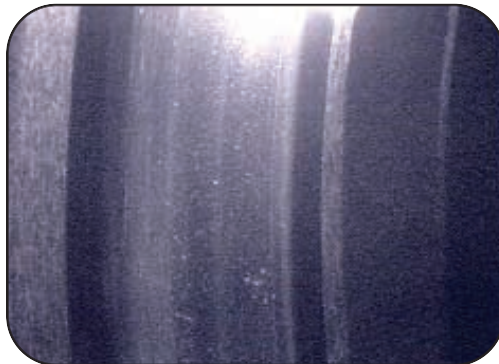
A low clamp load allows the displacement of the inner rings, and leads the bearing to operate without the proper preload, but in conditions of high axial clearance.

During the operating life the clearance tends to increase, as shown from the large, and often double, path patterns on the raceway of the bearing.

Magnification of the raceway showing a double path pattern.

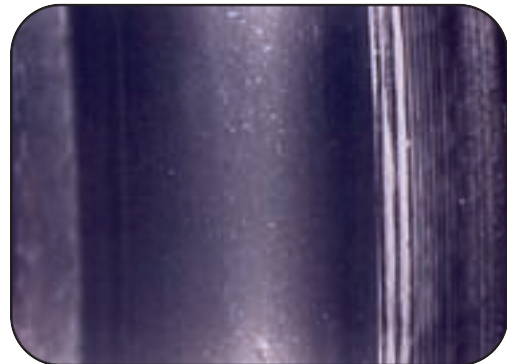
Magnification of the raceway showing a large path pattern.

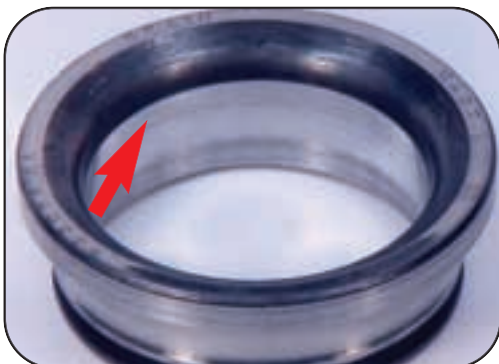
In addition, the inner rings could also rotate in respect to the shaft, as shown by the shiny surfaces of the bore diameters.

Sign of rotation on the inner ring bore diameter (shiny surface).

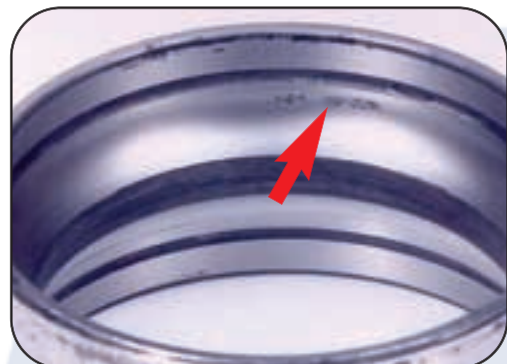
The improper running conditions can create flaking on the raceways, that generate noise during rotation.

Final flaking on an outer ring.

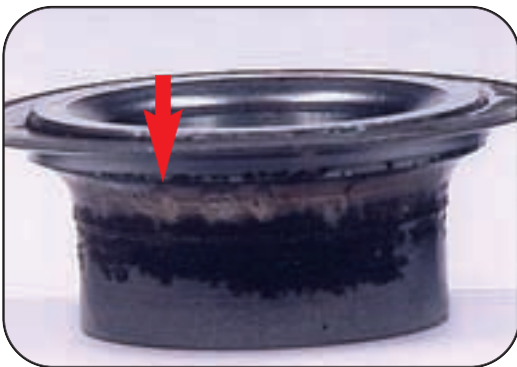
Flinger misalignment on an inner ring.

A shock load applied on a sealing component can remarkably affect its function, leading to an improper contact between the seal lips and the flinger surfaces, reducing in this way the sealing properties. In these conditions the ingress of water and/or other contaminants (dirt, dust) may occur.

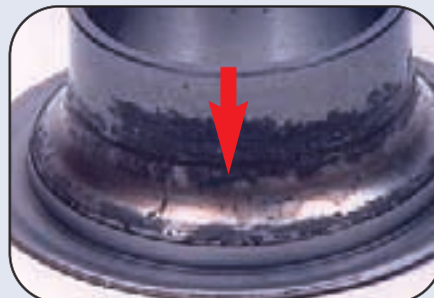
Oxidation takes place when water or corrosive elements reach the inside of the bearing in such quantities that the lubricant is not able to provide protection for the steel surfaces. The consequence of this process is the formation of corrosion pits, with finally spalling of the surfaces, particularly in the contact areas between the rings and the rolling elements.

Effects of the water ingress showing oxidation on a raceway.

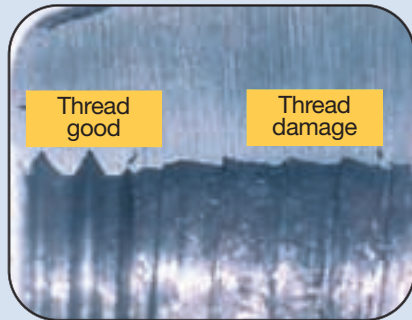
Section of a damaged threaded hole

Thread damages occur on bearings with flanged rings (HBU2 & HBU3) during the screwing/unscrewing operation, when a misalignment between the nut and the hole axis takes place.

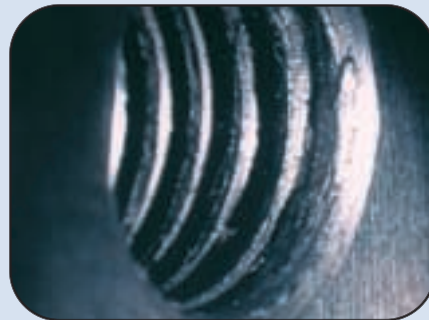
View of a damaged threaded hole

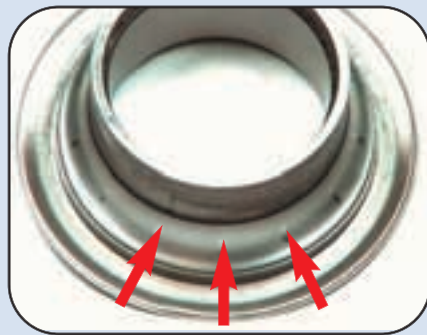
Plastic deformations on a bearing raceway

Plastic deformation occurs whenever the yield strength of the material is exceeded. Overloading by static or shock loads, leads to plastic deformations with the formation of surface depressions on the bearing's raceways, at rolling element pitch. These plastic deformations of the raceway at intervals corresponding to the rolling elements pitch can lead to subsequent flaking by over-rolling at a later stage.

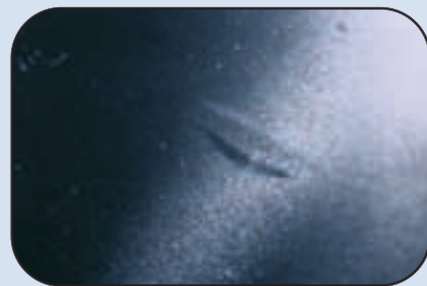
Magnification of an indentation on one ball

Raceways and rolling elements may become dented if the mounting force is applied to the wrong ring so that it passes through the rolling elements. Overloading can also occur by excessive preloading, damaging in this case not only the balls but even the other components.

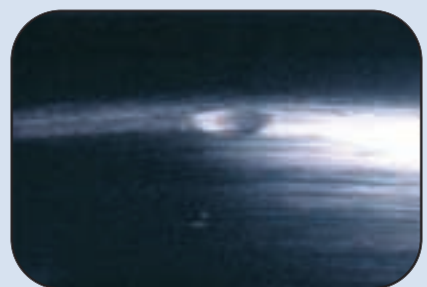
Magnification of a raceway: imprint due to the over-rolling of a damaged ball

Imprints on the raceways can be generated by the over-rolling of damaged rolling elements. Flaking can subsequently occur at a later stage.

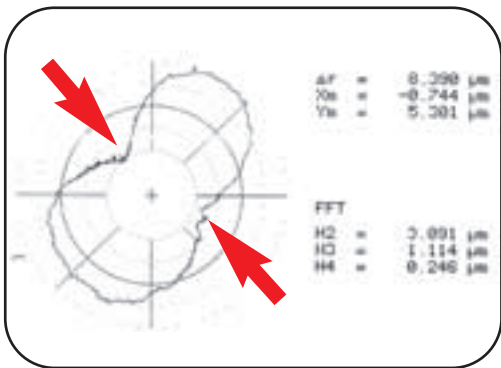
When the outer ring is fitted in a defective housing (oval or taper), plastic deformations take place, causing damages to the raceways, that could lead to spalling at a later stage. The deformations that occurred are clearly visible if a roundness measurement of the ring raceway is performed (see picture below). The spallings are located where the squeezing effect of the surrounding component is maximum, forcing the raceway diameter to be minimum.

This graph shows the deformed form of the raceway due to the defective housing. The red arrows point out the two palled areas, corresponding to the sectors of minimum diameter.

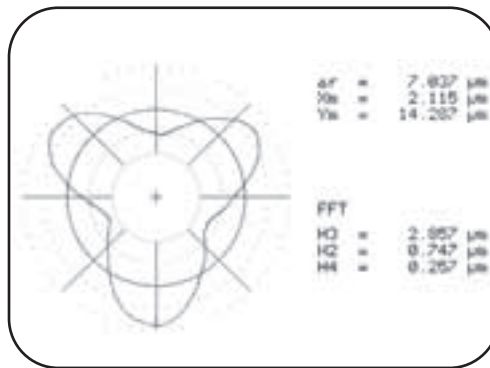
This graph shows the deformed form of the raceway due to the defective shape of the shaft. The measurement was performed with the inner ring still fitted on the hub.

When the inner rings are fitted in a defective shaft, plastic deformations can take place, affecting the operating conditions. The fitting in a taper shaft can lead to heavy damages to the raceways, forcing the rolling elements to roll in defined pattern, with higher contact pressure.

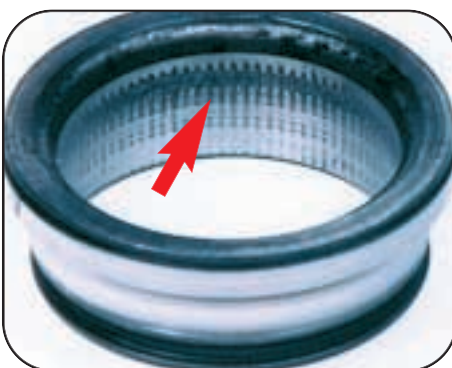
Indication that the raceway has suffered damage from a vibrating shaft within the inner ring bore diameter.

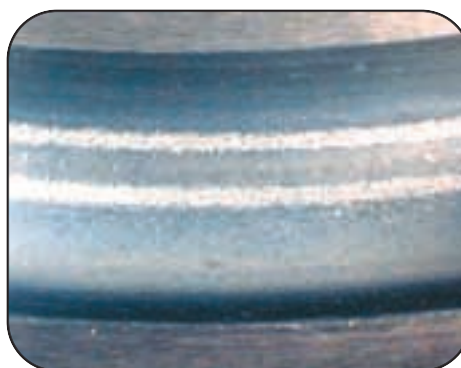
Magnification of a raceway showing signs of damages due to high contact pressure.

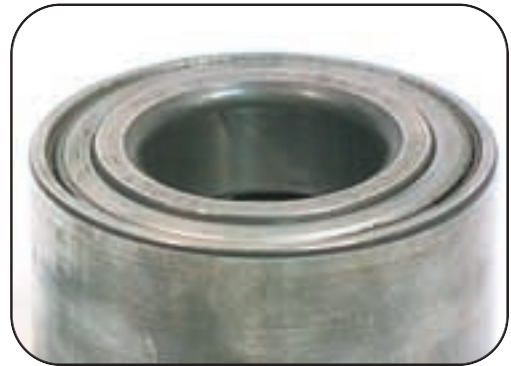
Seal in an oblique position due to wrong fitting during mounting into the knuckle.

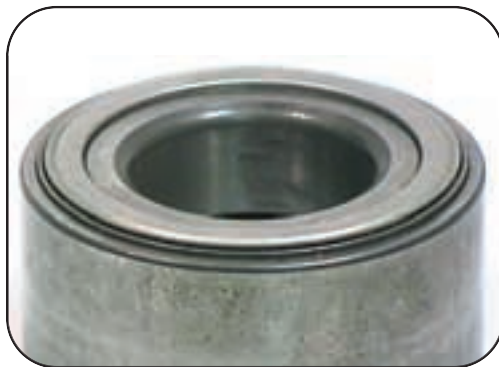
Seal standing out from inner and outer ring due to wrong fitting.

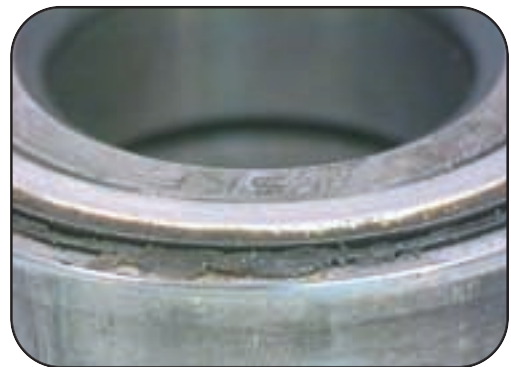
Detail of picture at left showing grease leakage.

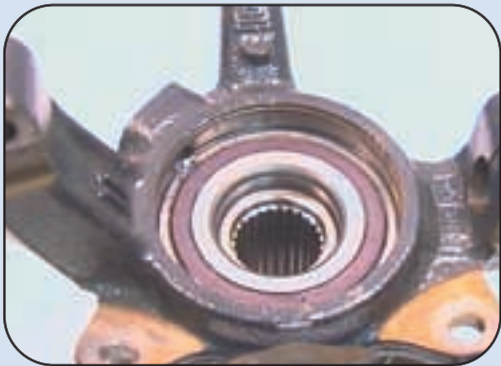
The wrong position of the seal flinger is due to improper fitting on the knuckle and spindle. Always verify lineup of the inner and outer rings.

All bearings are sensitive to shock and impact. You should **never use a hammer** in fitting a bearing. SKF recommends only proper fitting tools be used.

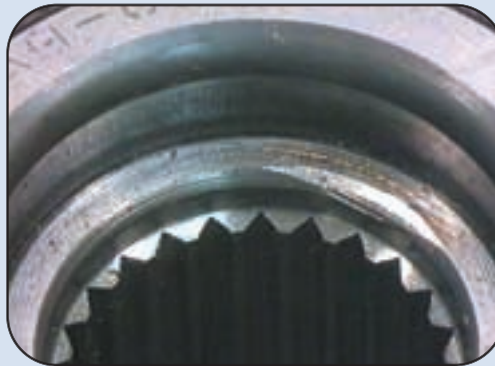
Close-up showing damage to the spindle and incomplete fitting of the inner ring to the spindle.

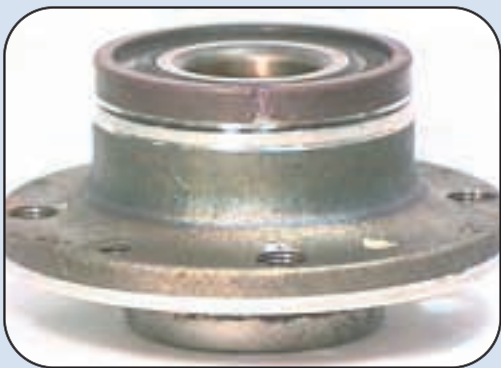
ABS sensor ring broken as a result of an external agent while car is running.

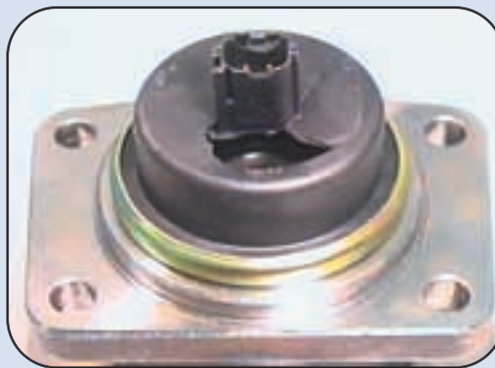
ABS cup is broken due to incorrect handling or improper fitting.
